Los Angeles River Watershed Monitoring Program 2019 Annual Report

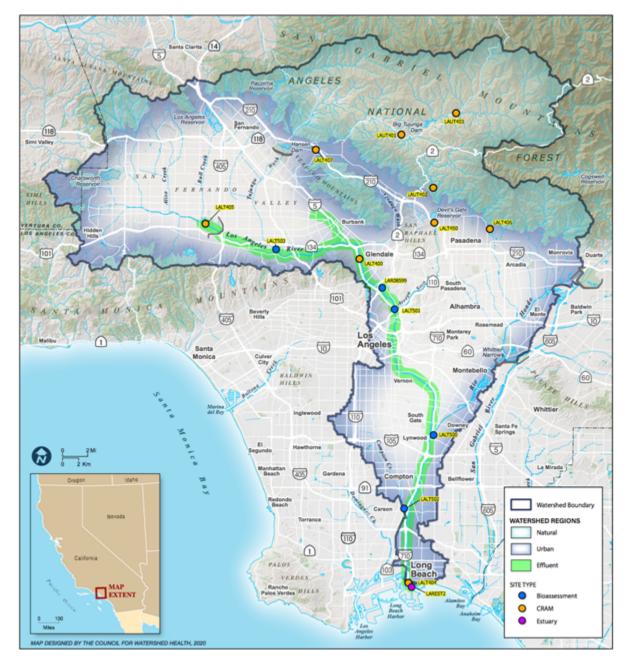
Figure 18. Location of bioassessment, CRAM, and estuary sites.

- Trends at freshwater target sites: Four target sites were established on lower watershed tributaries upstream of their confluence points with the Los Angeles River to monitor water chemistry and assess biological, riparian, and physical habitat condition (Figure 18). These sites differ from the random sites used to assess ambient watershed condition in that their locations are fixed and sites are sampled regularly. Over time these data are being used to assess trends and to determine if changes in these trends can be attributed to natural, anthropogenic, or watershed management changes. Due to the amount of data that has been collected from confluence sites, in 2018 the TSG included another site of interest. This site will be semi-regularly sampled along with other confluence sites on an alternating basis. The 2019 monitoring program included Lewis McAdams Park, a random site that was sampled in 2015, dredged in 2018, and revisited in 2019.

A total of 44 samples have been collected from the four confluence locations during the eleven annual surveys from 2008 to 2019 (Figure 18 and Table 8). In 2018, the TSG agreed to begin monitoring near Lewis MacAdams Park, a site that would aid the TSG in understanding the impact of sediment removal to stream health. Samples were collected and analyzed for aquatic chemistry, and biological and riparian habitat condition. The goal of repeated annual sampling at these locations is to monitor changing conditions related to water quality and riparian, physical habitat, and biological condition at the three sub-regions of the watershed.

Targeted Confluence Locations	Channel Type	Site ID	Latitude	Longitude
Confluence of Rio Hondo and mainstem of LA River	Lined	LALT500	33.93642	-118.17147
Confluence of Arroyo Seco and mainstem of LA River	Lined	LALT501	34.08059	-118.22475
Confluence of Compton Creek and mainstem of LA River	Unlined	LALT502	34.84529	-118.20784
Confluence of Tujunga Wash and mainstem of LA River	Lined	LALT503	34.14833	-118.38916
Lewis MacAdams Park	Unlined	LAR08599	34.10603	-118.24338

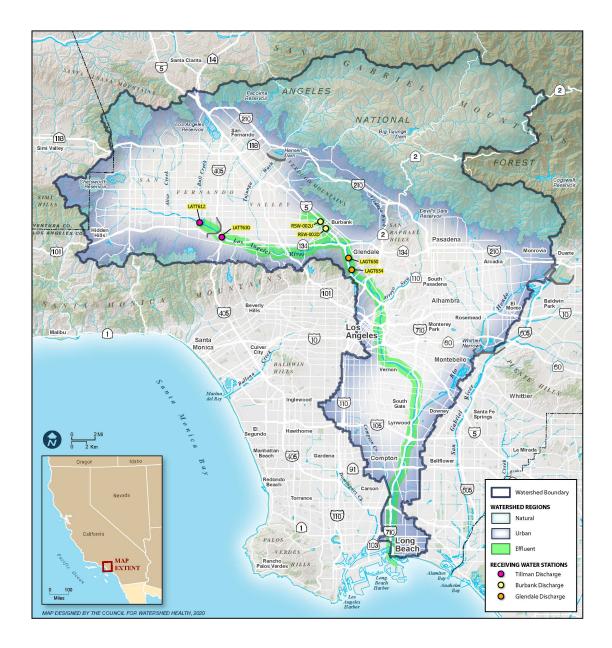
Figure 24. Locations of NPDES receiving water sites monitored by the City of Los Angeles and the City of Burbank.

This chapter summarizes NPDES monitoring data for the period from January through December 2019 for three major POTWs that discharge into the Los Angeles River: The City of Los Angeles' Tillman Water Reclamation Plant (DCTWRP), the City of Los Angeles' Glendale Water Reclamation Plant (LAGWRP), and the City of Burbank's Water Reclamation Plant (BWRP). Site codes for the receiving water stations upstream and downstream of each POTW's discharge and their locations are shown in Table 10 and Figure 24, respectively. These receiving water stations are monitored by the permittees as a requirement of their NPDES permits and were chosen to best represent locations upstream and downstream of the discharge locations. Values were compared to LARWQCB Basin Plan Water Quality objectives (Table 11).

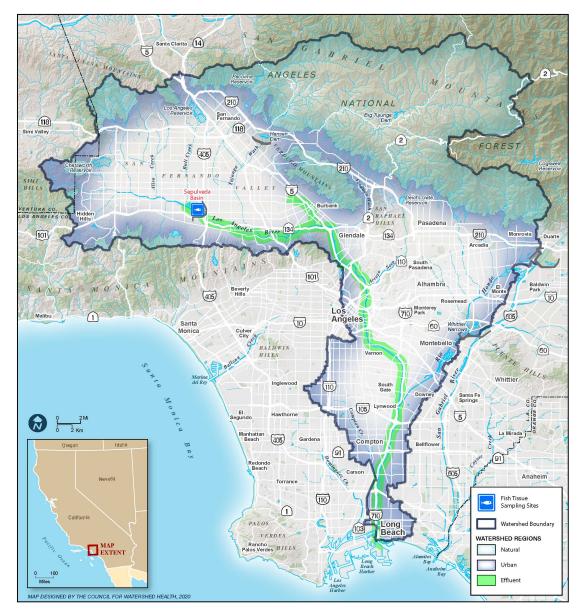
Figure 32. Fish tissue sampling location for the 2019 bioaccumulation survey.

A total of 14 fish were successfully collected from Sepulveda Basin including, common carp (*Cyprinus carpio*), bluegill sunfish (*Lepomis macrochirus*), and green sunfish (*Lepomis cyanellus*) (Figure 32). They were combined, by species, into four separate composites. On average, the largest fish captured in the lake was common carp (1400 g), while the smallest fish caught was green sunfish (37.5 g) (Table 33).
